The spire of St John the Divine

ST JOHN THE DIVINE, KENNINGTON; THE SPIRE

Giles Quarme describes the restoration of one of Street's greatest works

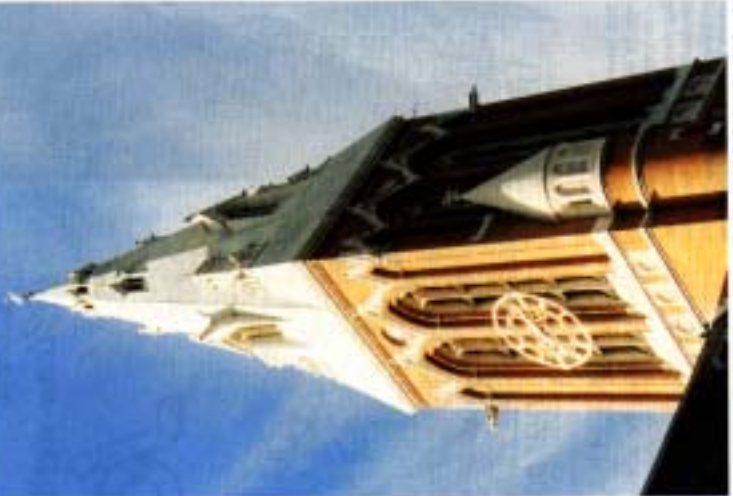
agreed to a maximum of 2100 per square m. was adopted. The low pressure employed managed to clean most but not all of the pollution on the brick face. The total removal of the pollution could not be achieved without abrading the surface of the brickwork as the red brick employed by Street was extremely 'soft' and did not have the strength of a typical London stock brick.

Large areas of brick-work on the tower had spalled. The damage was principally due to water saturation and subsequent frost damage rather than atmospheric pollution. In addition there were a number of structural cracks penetrating through the full thickness of the tower walls. They had originally been caused by subsidence and further exacerbated by Second World War fire bombs. The tower had not been properly tied into the nave of the church when it had been constructed a number of years after the completion of the rest of the church. The structural cracks were cut out by removing the adjacent damaged brickwork and new bricks were bonded in using a combination of chemical fixings and grout. With the damaged areas of mottled brickwork the on-site bricklayers and masons had to cut and rub the new bricks to match the existing profiles and mouldings.

The clock tower - cleaning away the pollution which had given it a dark red appearance revealed the bright red, smoked salmon coloured brick.

By using deceptively thin bricks an optical illusion of a taller tower is achieved. The benefit derived from this 'architectural ruse' was slightly counterbalanced by the need to have approximately 3000 special new bricks made to carry out the repairs. The Suffolk firm, Bulmer Brick Company, cut out samples and supplied the new bricks, which not only had to match in size, but also in colour. The initial sample panels carried out to decide on which chime ring system to adopt revealed that the tower was not constructed of dark red bricks as previously envisaged, but of a bright red, smoked salmon coloured brick. The contrast between the newly cleaned tower and the old, dirty nave is quite striking.

Various different methods of cleaning the brickwork were tested, such as water, water and hydrofluoric acid and a number of abrasive techniques to see which would be the most effective and least deleterious to the face of the brickwork. The technique eventually adopted was the jet system which had been recently introduced from Germany. The technique involved the use of a high pressure water jet directed at the brickwork from a distance of 10m. The jet was controlled by a remote control device and the water was collected in a tank below the tower. The jet was used to clean the brickwork in a number of stages, starting with a low pressure jet to remove the surface dirt and then a high pressure jet to clean the brickwork. The jet was used to clean the brickwork in a number of stages, starting with a low pressure jet to remove the surface dirt and then a high pressure jet to clean the brickwork.
